TECHNICAL REPORT ARBRL-TR-02476

SCANNING ELECTRON MICROSCOPE
EXAMINATION OF COTTON LINTERS AND WOOD
PULP FIBERS BEFORE AND AFTER NITRATION
AND GUN PROPELLANT MANUFACTURE

US ARMY ARMAMENT RESEARCH AND DEVELOPMENT COMMAND
BALLISTIC RESEARCH LABORATORY
ABERDEEN PROVING GROUND, MARYLAND

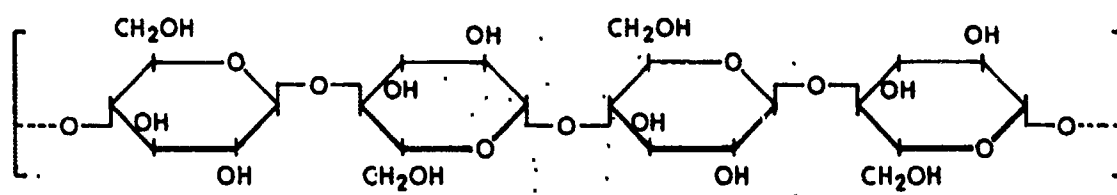
Figure 1. Cellulose [$\beta(1,4)$ D-Glucosepyranose] Molecule

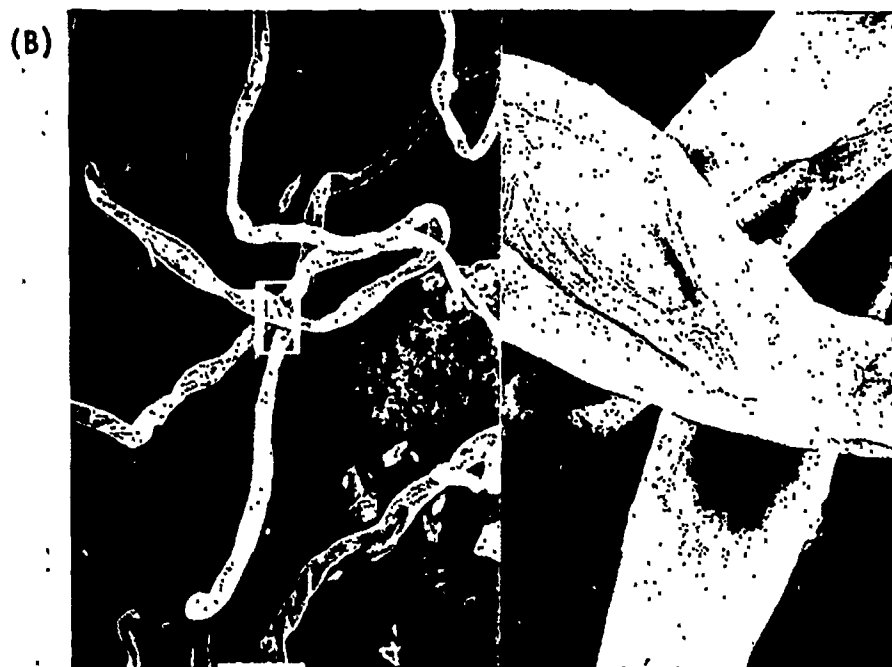
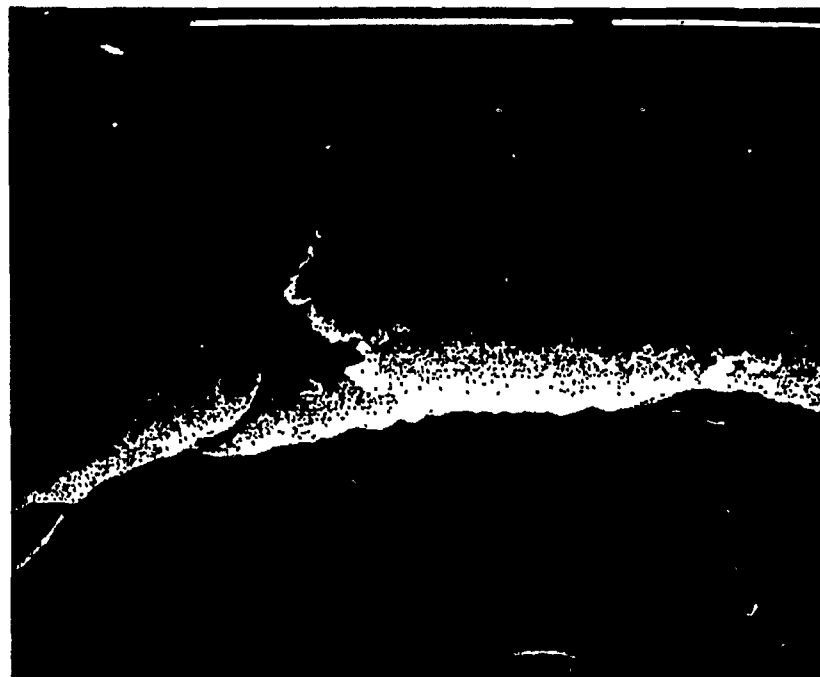
Figure 5. Buckeye Cotton Linter Cellulose Fibers

Comment (Cont'd): image size during reproduction these values no longer give the actual magnification. These numbers are included for reference with all of the photomicrographs of this report. See description of micrograph white size bars on page 16.

1. Cotton Linter Celluloses. There were no major differences between the two cotton linter samples provided. (See Figures 5 through 9.) The linters were intact, showing little evidence of mechanical or chemical degradation. Chemical degradation is generally observed as partial or total solvation of the entire sample and/or various microstructures. Some fibers did show some surface tearing of the outer cellulose layers as seen in Figure 6(d). Both linter samples show the typical mix of flattened, convoluted ribbons and the round, tapered fibers seen in optical micrographs of cotton linters. The fiber surfaces appeared smooth and undamaged. The overall views of the samples showed few broken ends and/or short fragments.

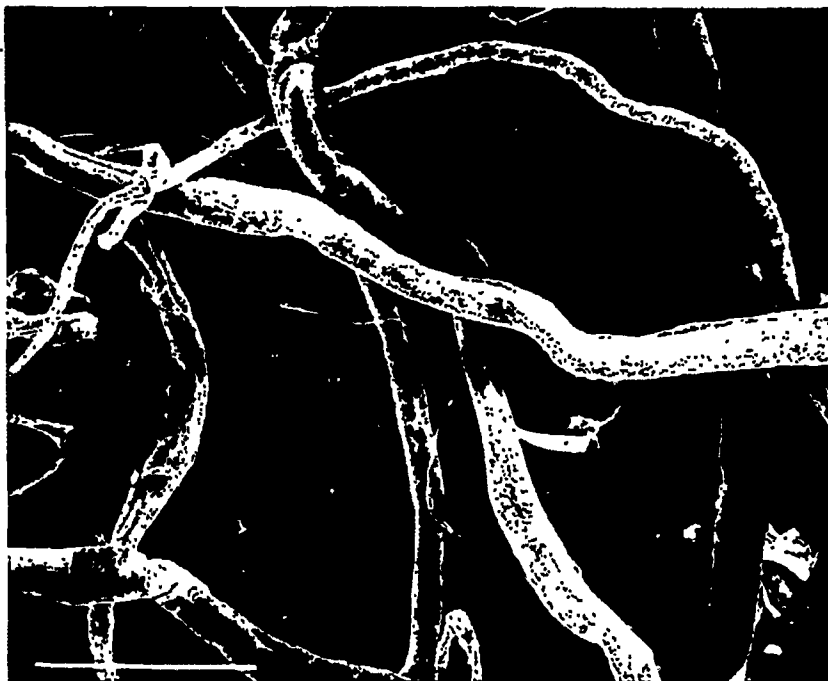
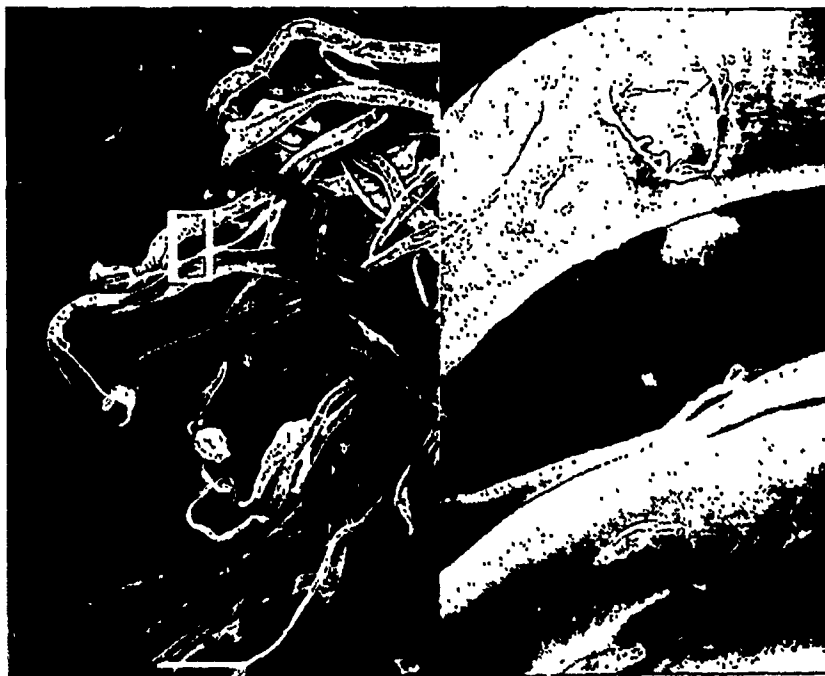
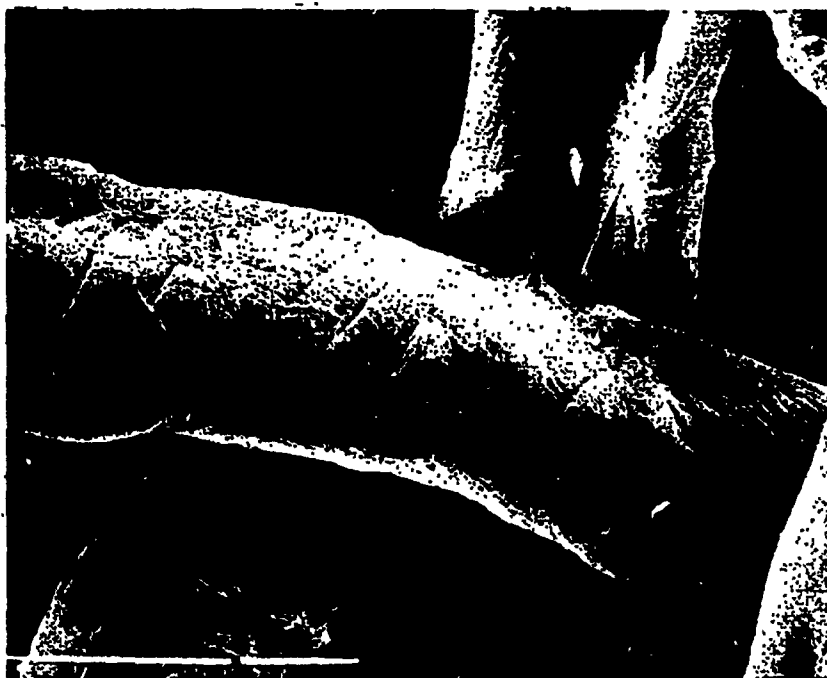
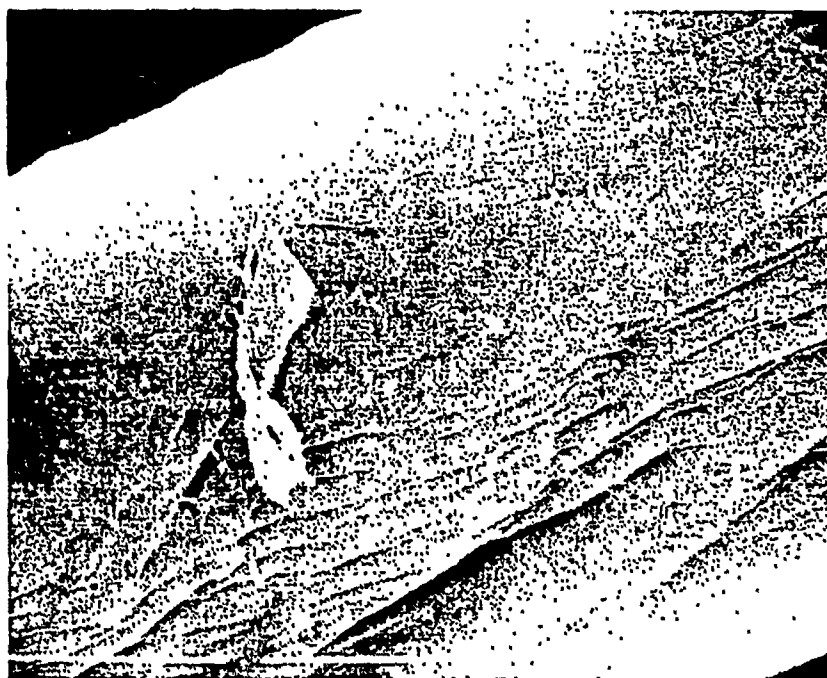
Figure 6. Hercules Hopewell Cotton Linter Cellulose Fibers

Comment: These linters show some mechanical damage. Micrograph C shows the typical cotton cellulose striations at 30° and the surface cracks at 60° to the fiber axis.

Cotton fibers are the hairs or trichomes formed on the epidermis of the cotton seed.³ These trichomes are extruded from the seed during the first stages of growth and are covered with part of the waxy cuticle of the seed.⁴ The dried trichome is marked by very characteristic twists or convolutions that occur at irregular intervals along its length, producing a flat convoluted ribbon. The cuticle is extremely thin and is not found after the trichome has been nitrated. The structure of the cotton exterior cell wall consists of parallel bundles of spiral wrapped fibrils making an angle of about 30° to the axis of the fiber. (See Figures 1(a) and 6(a).)

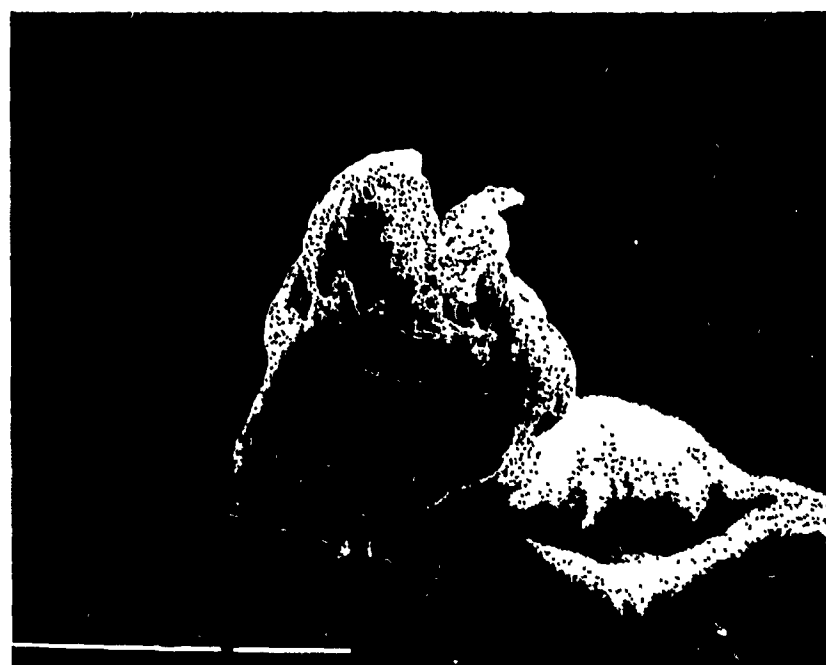
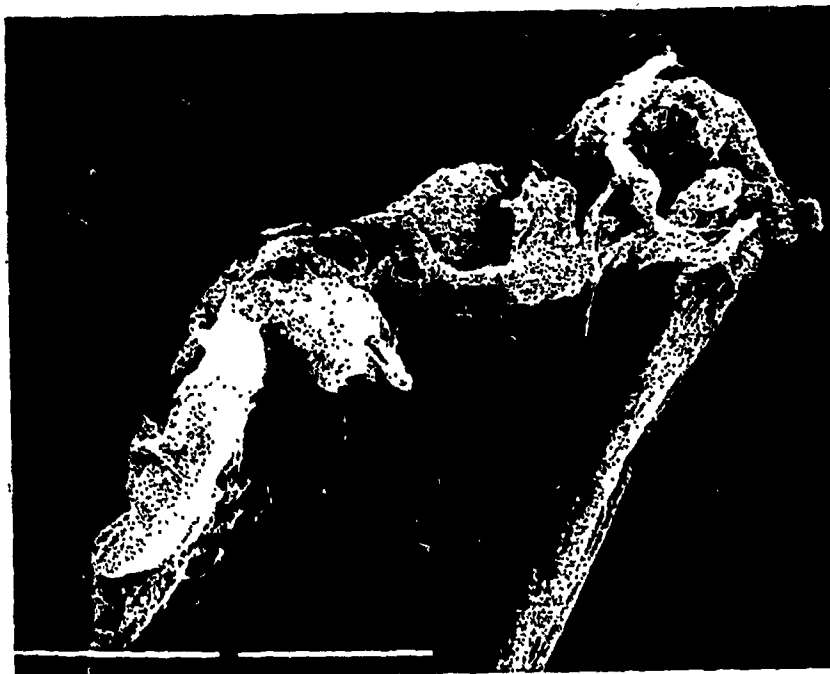
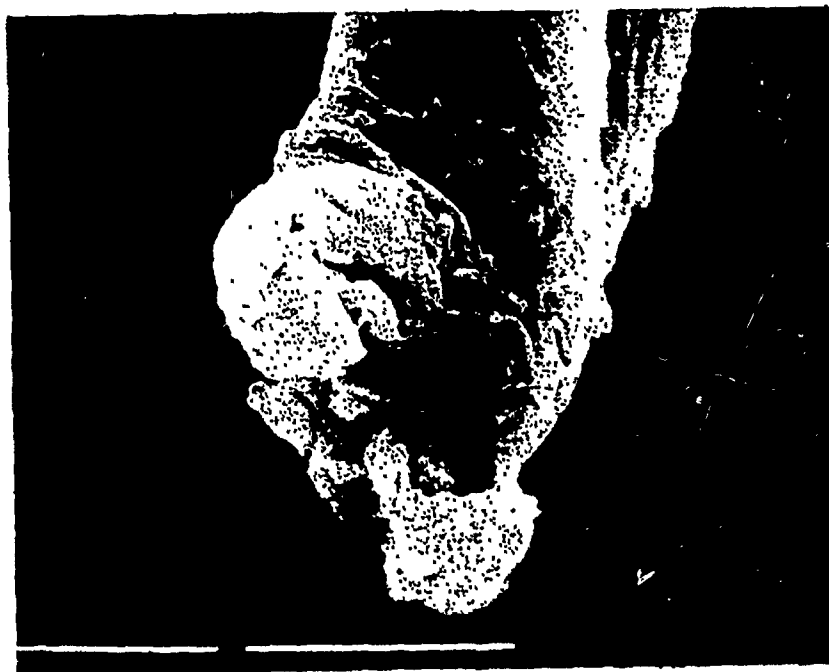
Figure 7. Fractured Buckeye Cotton Cellulose Fibers

Comment: These fibers were frozen in liquid nitrogen and then fractured. Notice that there is little evidence of major delaminations of the cell wall layers at the fracture surfaces.

The liquid nitrogen frozen linters, as seen in Figure 7, fractured with few cellulose strands, tufts and/or delaminations of the cell wall structure. This suggests that the fiber was relatively "crystalline" when fractured, resulting in a clean break. This also suggests a relatively

uniform structure and purity of the cell wall. Some delamination or splintering of the fiber ends would be expected if the S_2 cell wall layers contained different mechanical structures and/or regions of differing chemical composition. This fracturing evidence alone is not conclusive of structural or chemical homogeneity.

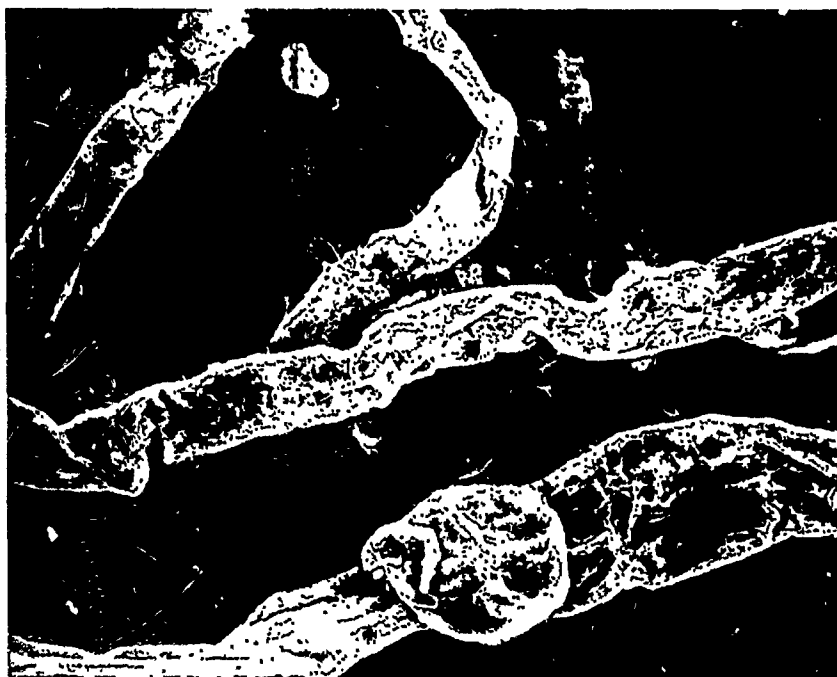
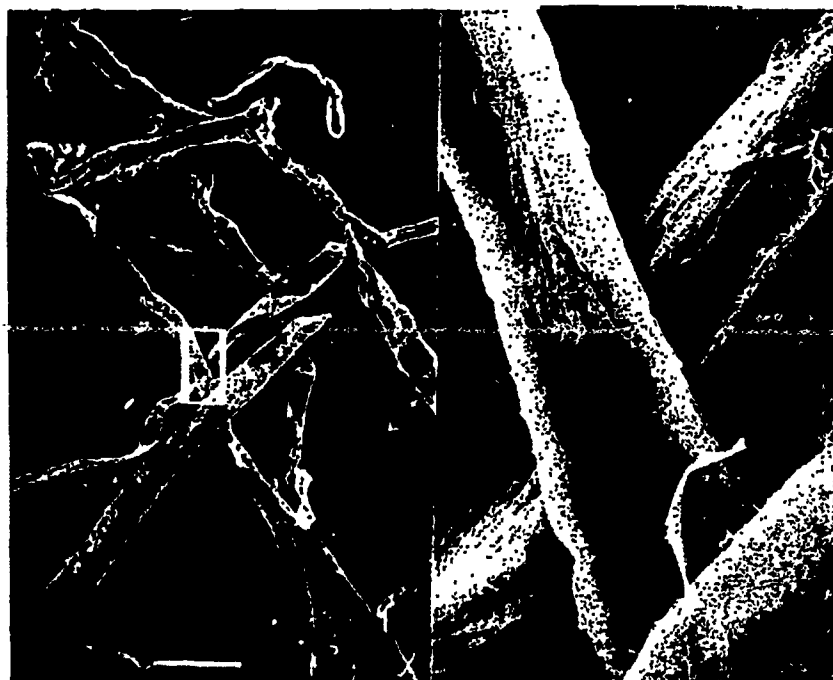
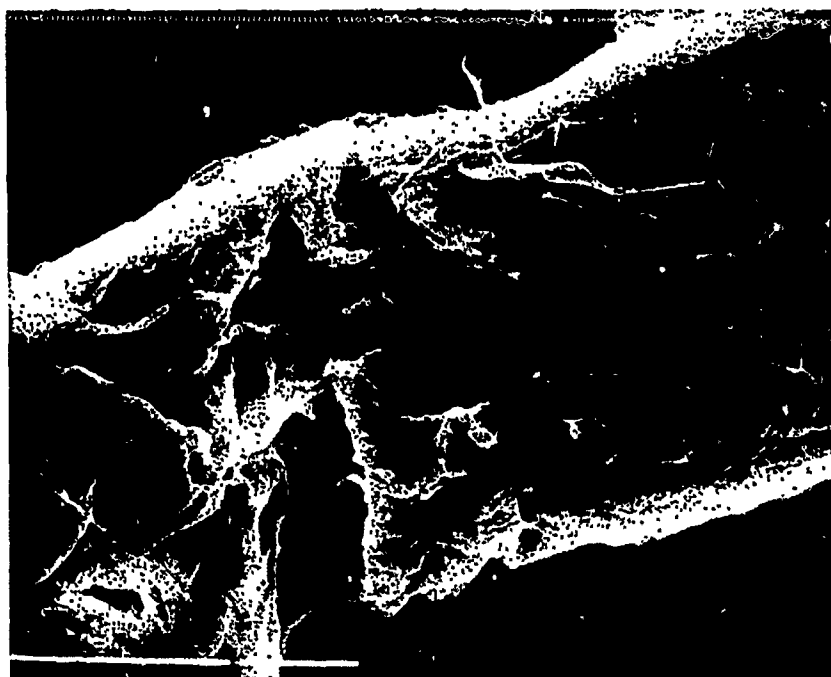
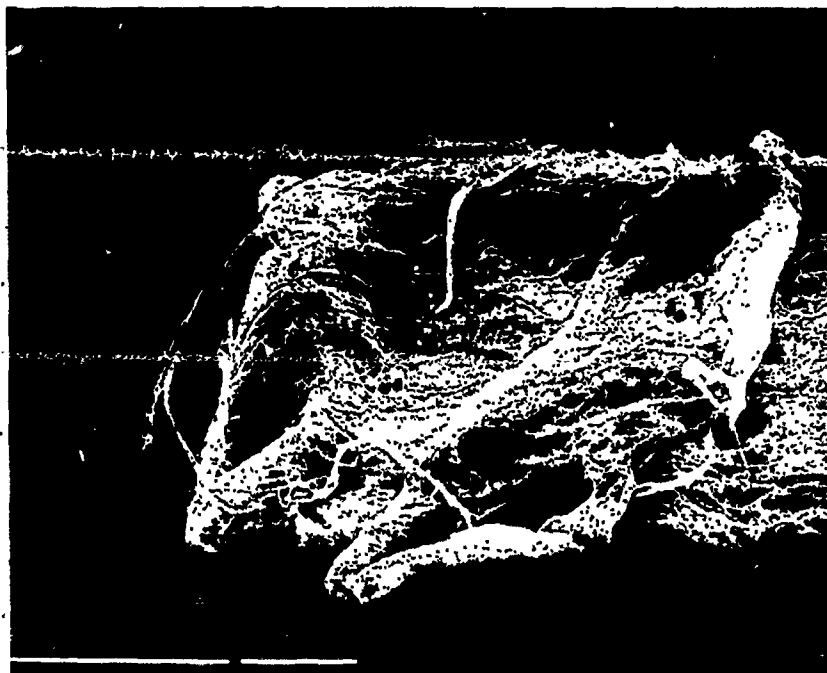
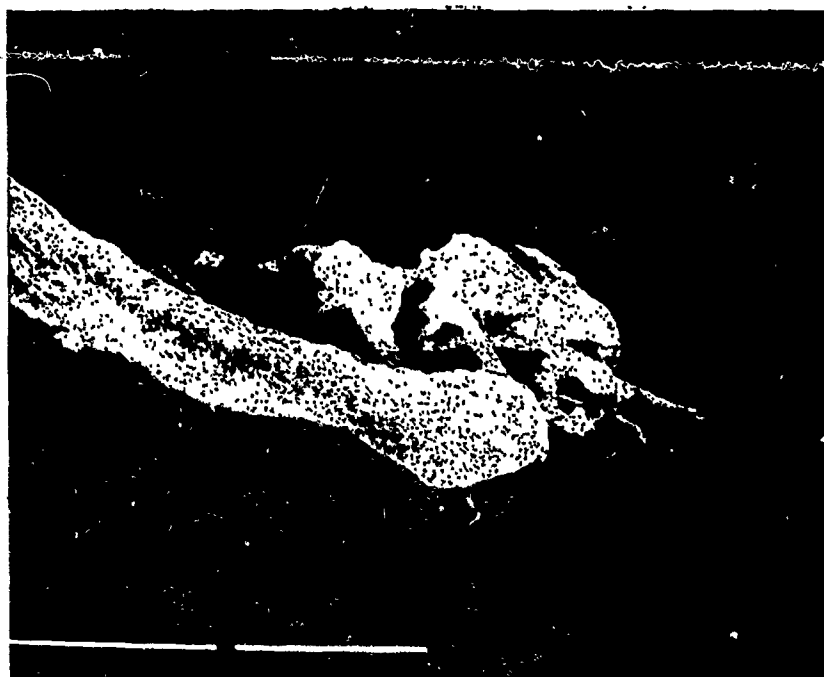
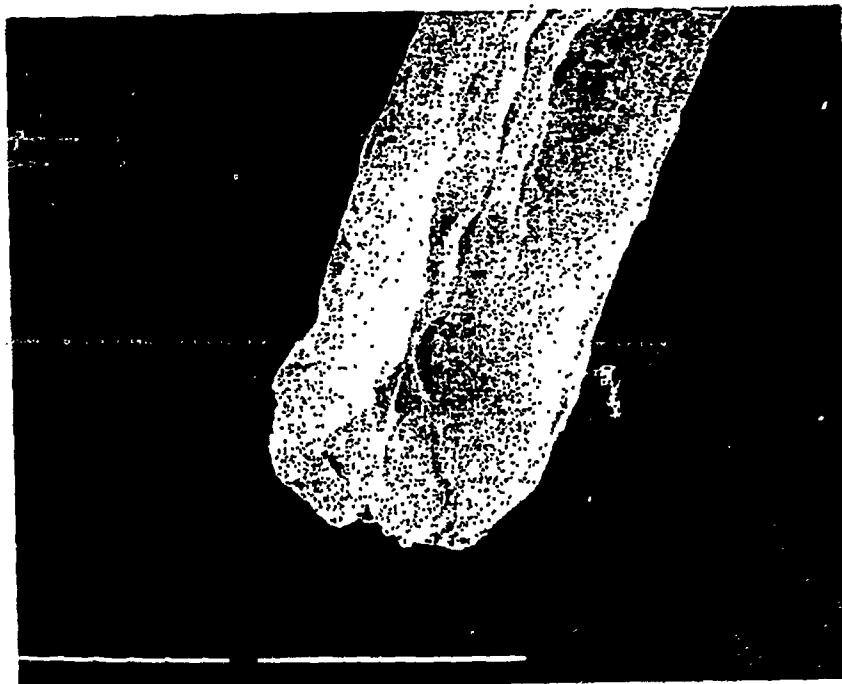
Figure 8. ITT Rayonier Wood Pulp Cellulose Fibers

Comment: These fibers are from Lot No. 5478 and were sulfite processed. Picture A is of an x-ray scan of these fibers. The large peak shows the presence of sulfur in the fibers. Note the mechanical damage on the

Comment (Cont'd): Micrograph E shows the outer cell wall layer delaminated and folded back along the fiber surface.

a. Softwood Pulp (Sulfate and Sulfite Processed). The softwood pulp fibers (Figures 8 through 12) show evidence of both mechanical and chemical damage. The overall views of all these samples show many broken ends and short fragments as compared to the long fibers found in the original trees. Most of the fibers exhibited hair-like structures on the surfaces, giving evidence of the tearing apart of the wood chips that occurs during processing. Figure 8(d) shows some of the chemical erosion that takes place during pulp processing. Here the chemical erosion appears as a partial solvation or "eating away" of regions of the cell wall with irregular surfaces and pits, but with generally smooth edges. The surfaces of the fibers appear roughened with many torn regions. Most of the fibers appear as flattened ribbons with the central lumen collapsed. The pits or pores typically seen in wood pulp cell walls can be seen in Figure 8(b) and 8(d). There is no readily apparent difference between the sulfate and sulfite processed pulps.

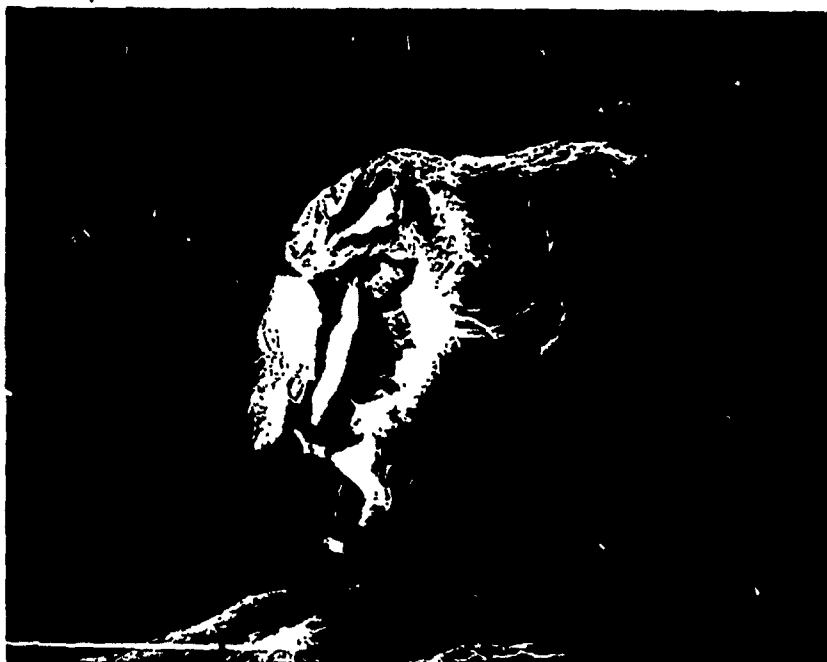
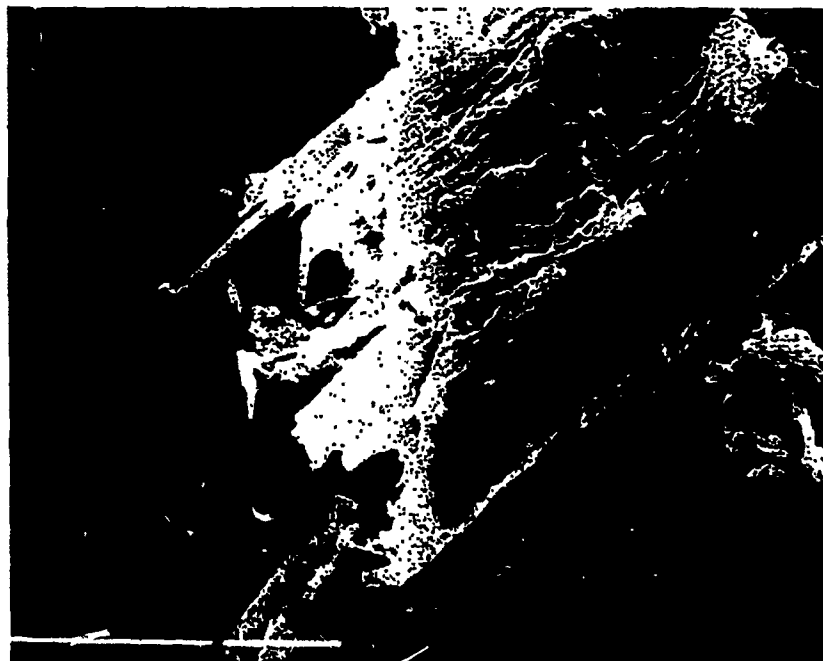
Figure 9. Fractured ITT Rayonier Wood Pulp Cellulose Fibers

Comment: These fibers are from Lot No. 5749 and were sulfite processed. These fibers were frozen in liquid nitrogen and then fractured. Note the delamination and splintering of the cell wall, indicating possible chemical and/or structural heterogeneity.

The liquid nitrogen fractured fibers did not appear to break as smoothly as the cotton linter fibers. (See Figures 9 and 12.) Figure 12 shows delamination of the secondary cell wall layer (S_2) with the central lumen readily visible. This suggests that either the fibers warmed up before they were fractured or that structural and/or chemical differences exist in these cell walls as compared to the other liquid nitrogen fractured samples.

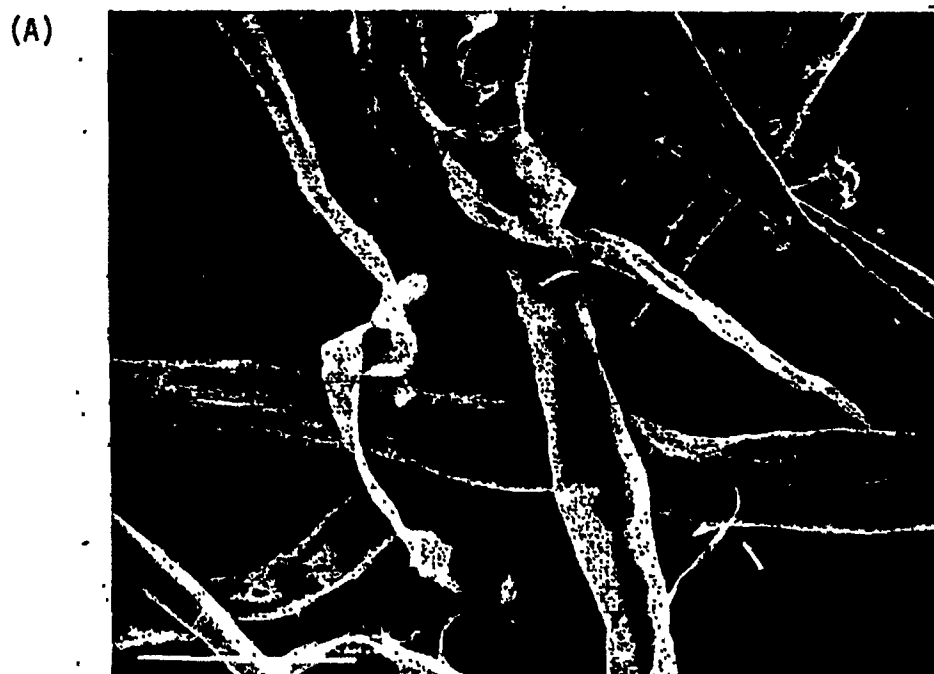
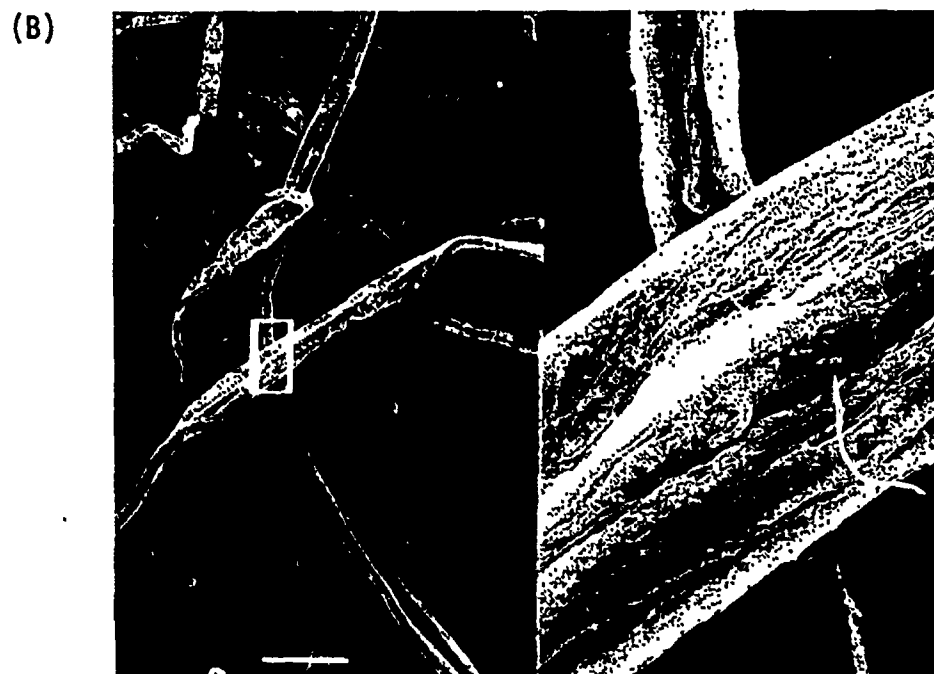
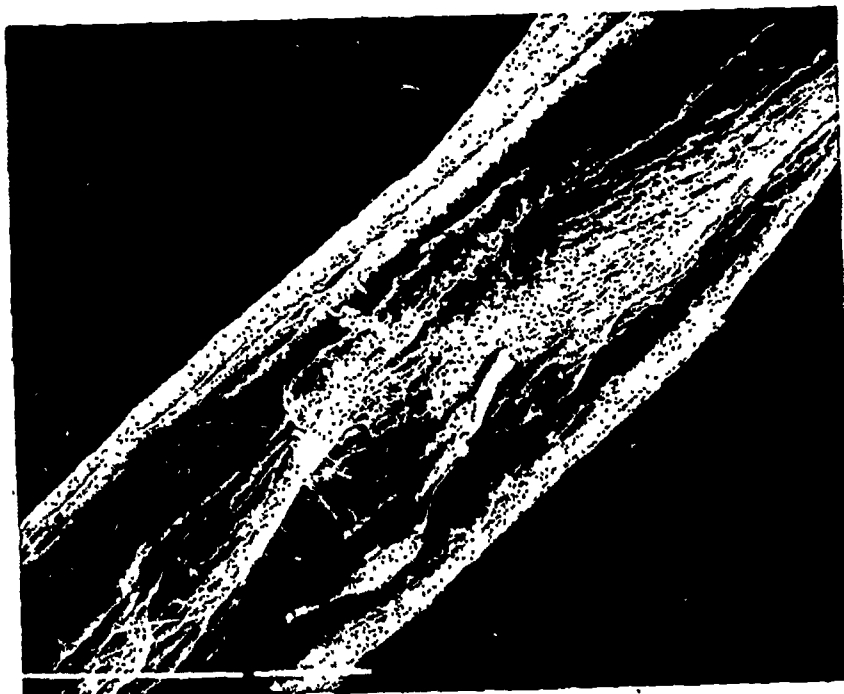
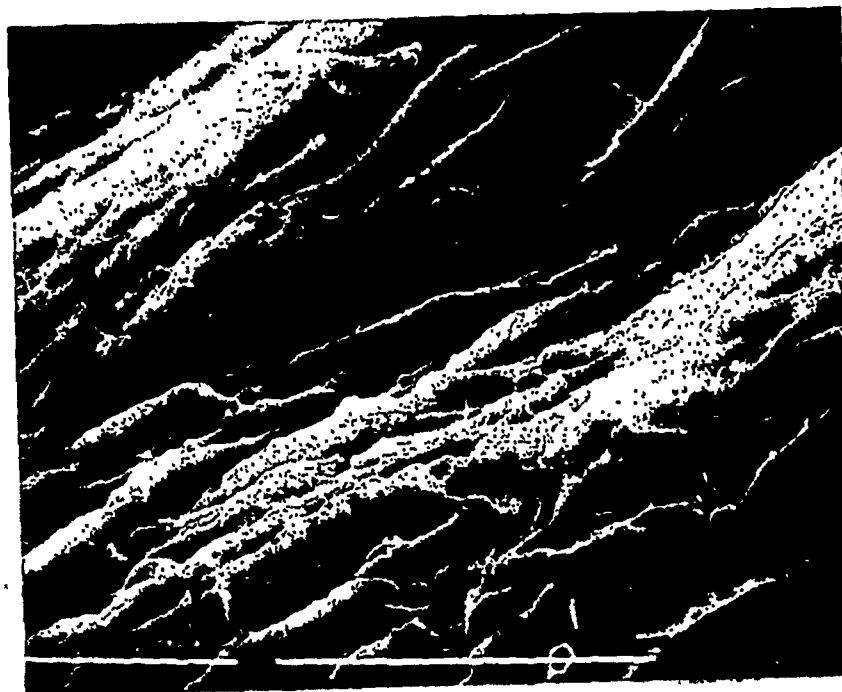
Figure 10. Buckeye Southern Pine Pulpwood Cellulose Fibers
(Sulfate Processed)

Comment: This sample contains 96 percent alpha cellulose. Note the mechanical damage on the fiber surfaces.

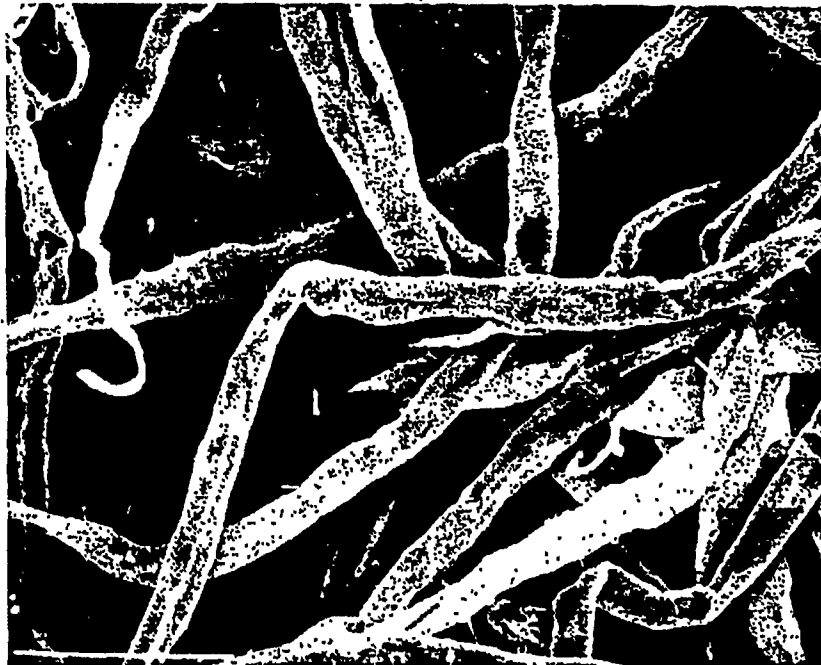
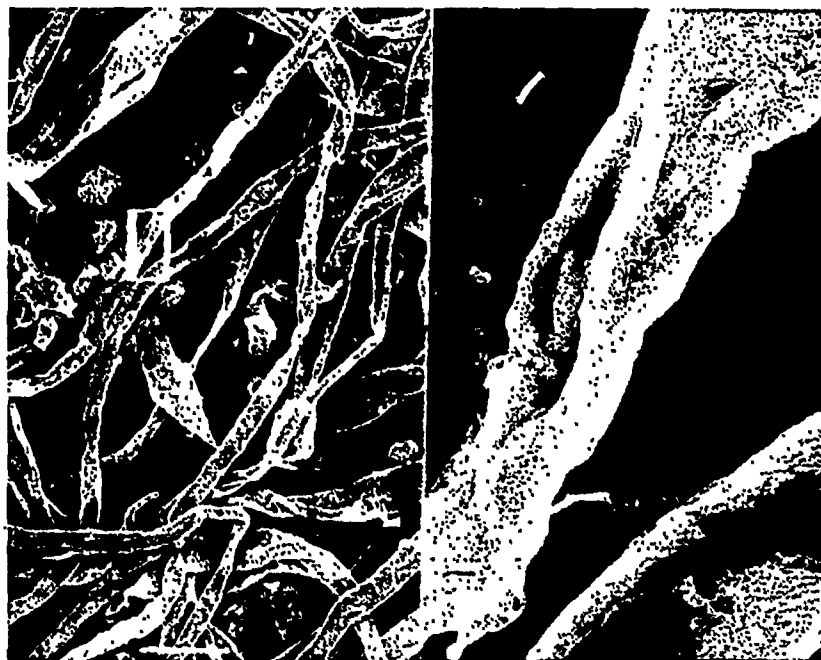
Figure 11. Alaska Lumber and Paper Company
Wood Pulp Cellulose Fibers

Comment: These fibers have been sulfate processed and bleached to increase the purity of the cellulose. Note the large number of fiber fragments in micrograph A.

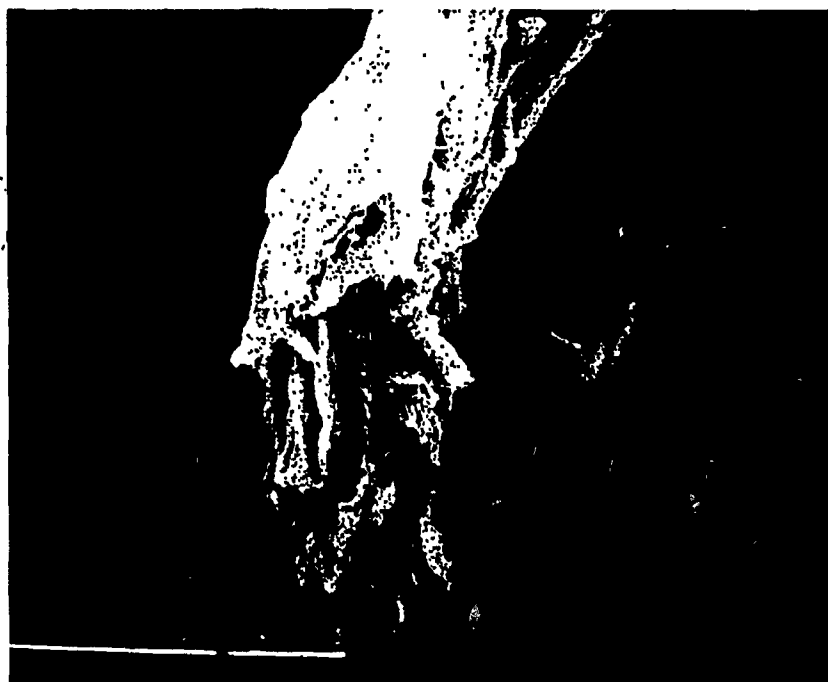
Figure 12. Fractured Wood Pulp Fibers

Comment: These sulfite processed fibers were frozen in liquid nitrogen and then fractured. Note the delamination of the secondary cell wall at the fracture surfaces.

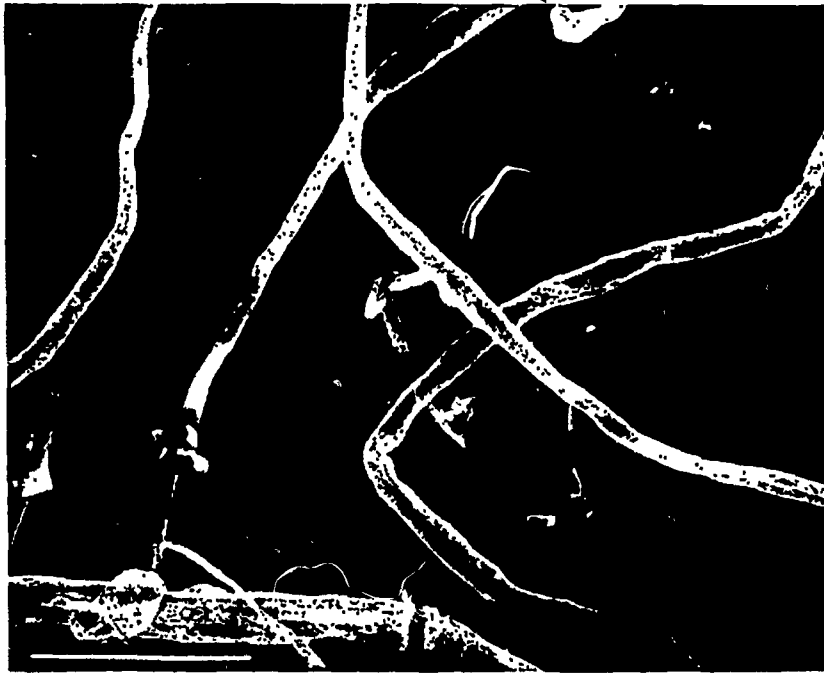
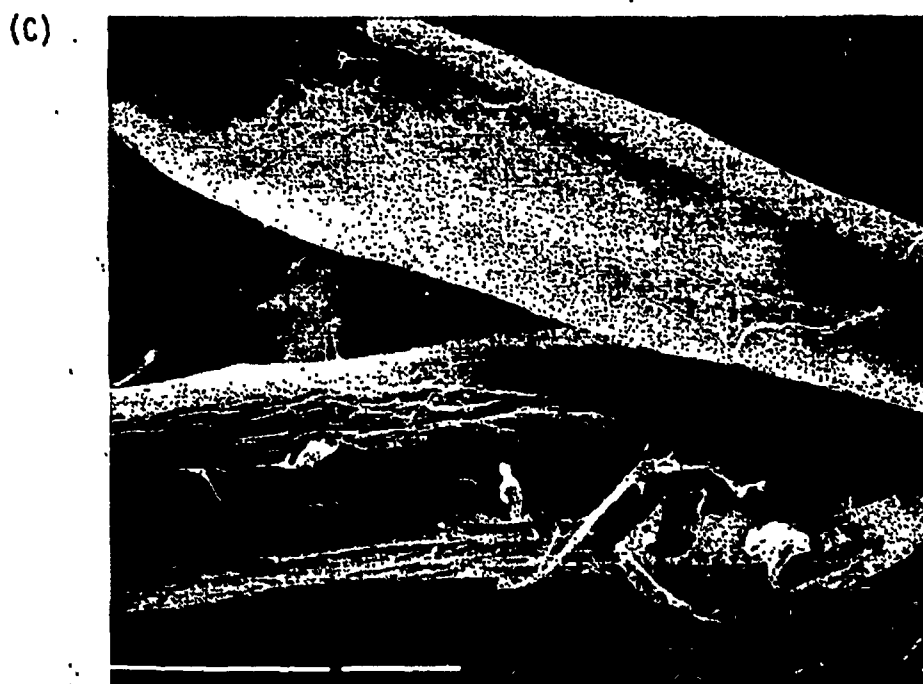
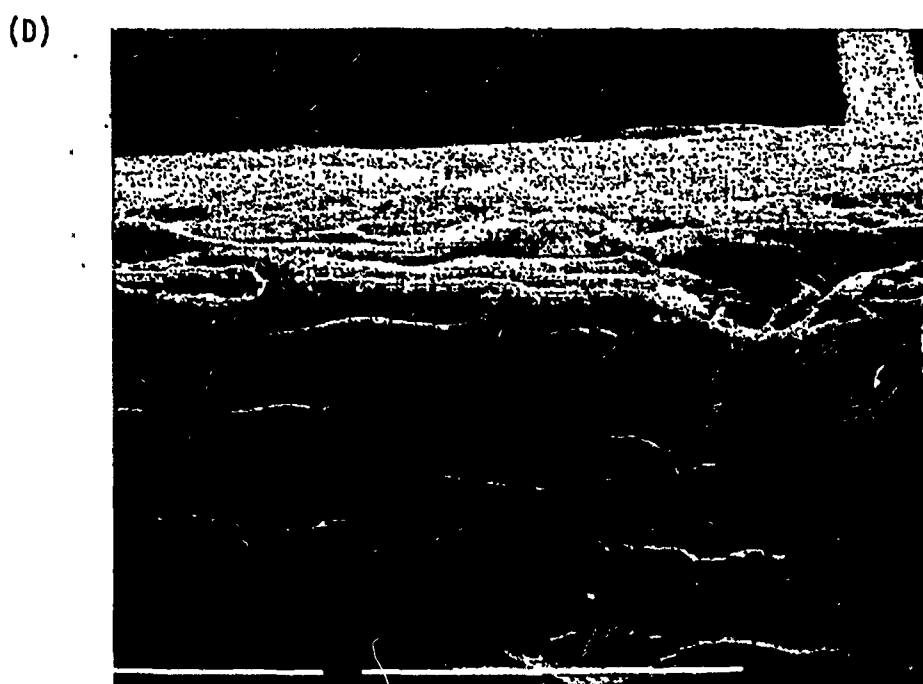
Figure 13. International Paper Company Hardwood
Wood Pulp Cellulose Fibers

Comment: Most of these fibers appear as flattened ribbons with the central lumen collapsed. Note the evidence of structural damage to the fiber surfaces.

b. Hardwood Pulp Fibers. The hardwood pulp fibers, seen in Figure 13, appear very similar to the softwood pulp fibers. The overall views of the sample show broken and torn fiber ends and numerous small, irregular fiber fragments. The main difference between the hardwood and softwood pulp fibers is that the hardwood fibers appear to show less mechanical damage to the fiber surfaces. Some of the hardwood fiber surfaces appear to be as smooth as those of the cotton linters.

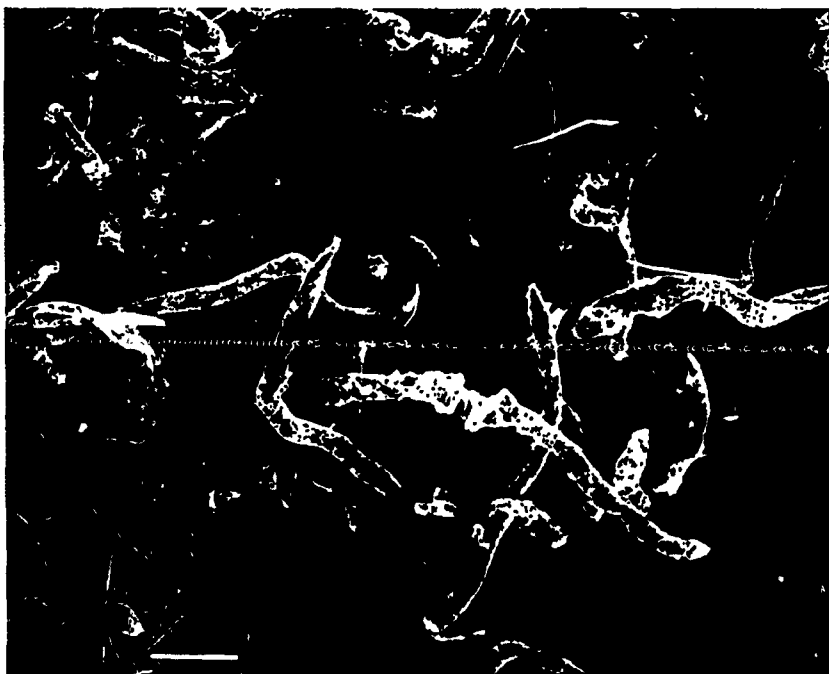
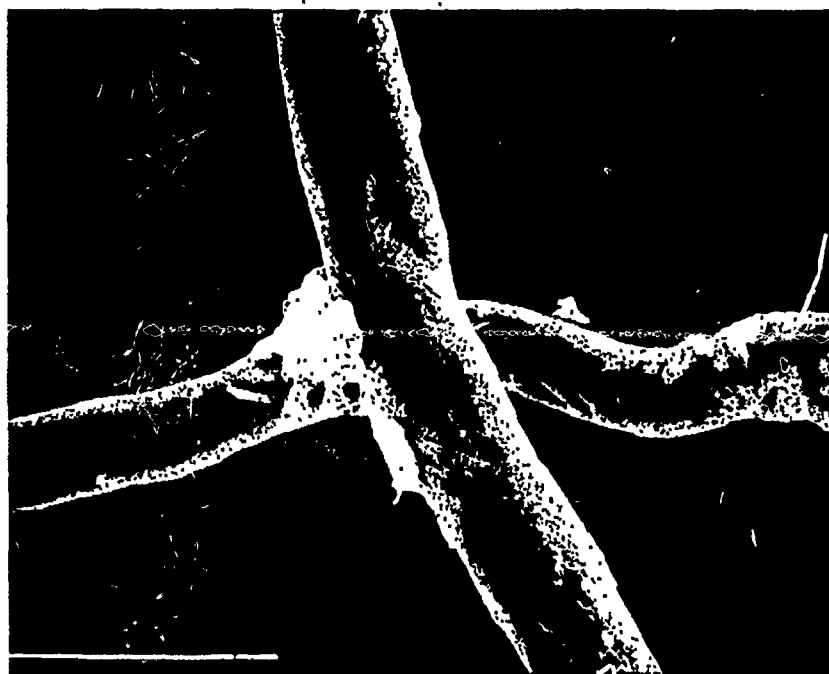
Figure 14. Cotton Linter Nitrocellulose Fibers

Comment: These fibers are from Lot BL-3. This sample contains 11.7 percent nitrogen. Note that the surfaces of the fibers are cracked and porous, with numerous, round, smooth-edged holes (approximately 0.1

mechanical damage compared to the cellulose linters. The nitrocellulose fibers show regions where the cell wall is split along the fibril structural pattern with the cellulose fibril bundles exposed. The surfaces show numerous smooth-edged pores that suggests partial solvation with subsequent rapid drying. Partial solvation of the cellulose occurs during nitration, especially by nitric acid, which is a strong solvent for cellulose.³ Almost all nitration processes use one or more rapid drying steps.

The cracks in the cell walls expose the structure of the cellulose fibrils. One explanation for these cracks is that they are the result of the rapid drying of the solvent-swollen cellulose fibrils. This induces stress on the cell wall structure, and the cracks appear at weak points, cleavage planes, and at the end of fibril bundles. The fibrils preferentially separate parallel to the 30° spiral twist of the fibrils seen in the cotton cellulose linter feedstock. This is seen in Figures 14(c) and 15(d). The depth of these separations generally appears to be on the order of 1 to 2 μm in most of the samples. This gives an indication of the depth of the outer layers (S_1) of the secondary cell wall. There was little evidence in all of the samples viewed of any cracks or fractures transverse to the fibril bundles. This suggests that the cotton linter fiber bundles are more or less continuous throughout the length of the cell wall and that the individual microfibrils are also very long relative to the length of the fiber.

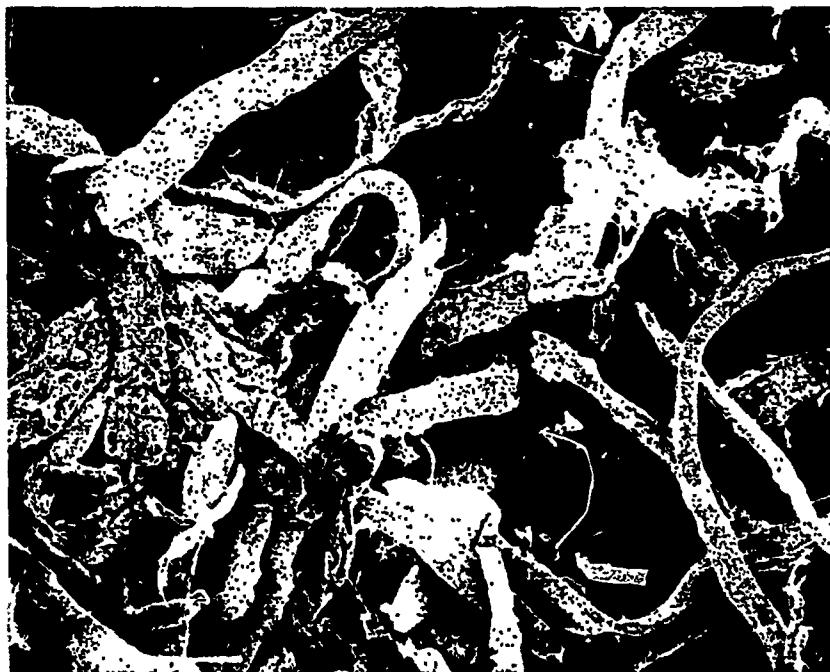
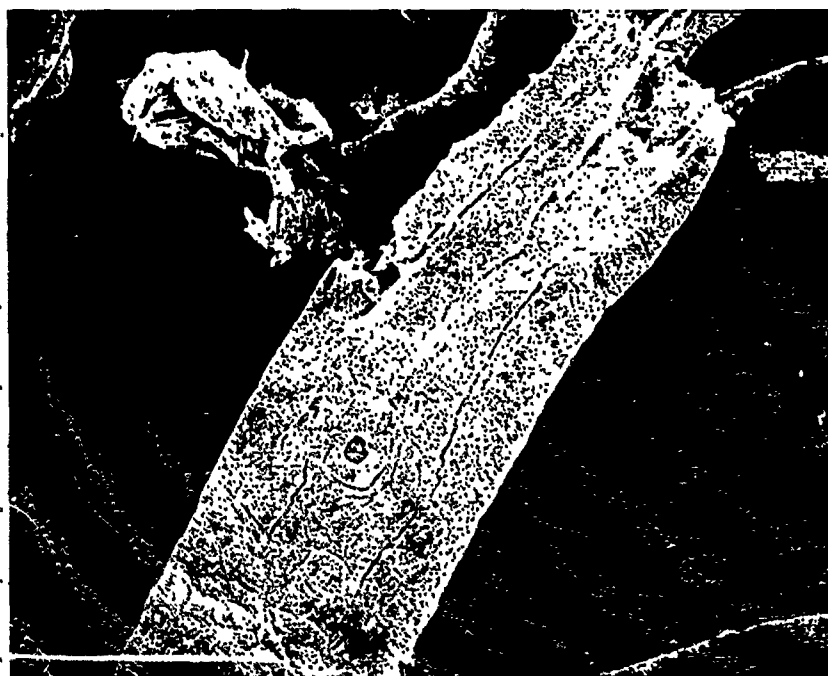
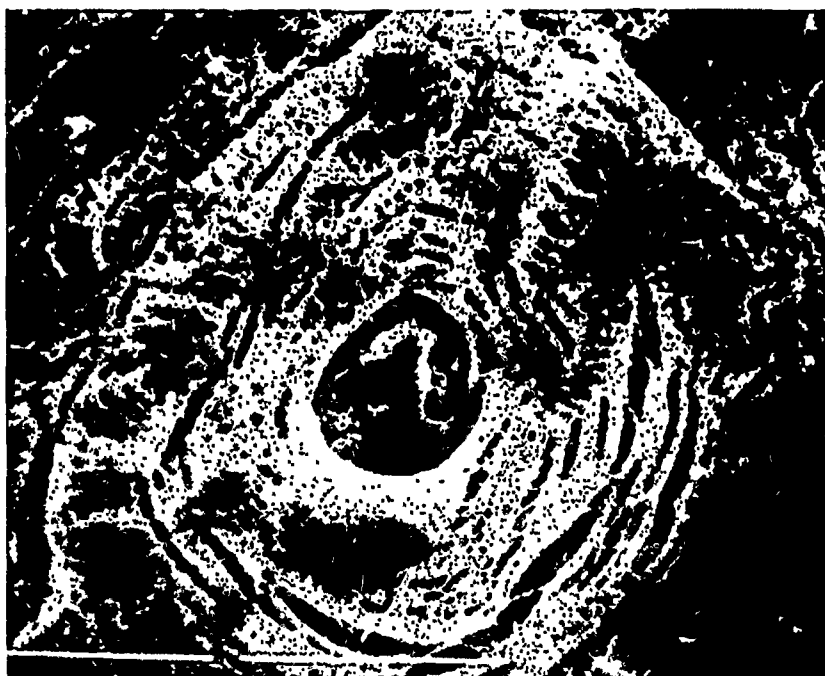
Figure 16. Southern Pine Nitrocellulose Fibers

Comment: These fibers are from Lot C-0936Y. The fibers show extensive mechanical damage with torn fiber ends and numerous small fragments. Note the bordered pits in micrographs C and D which are typical of

Comment (Cont'd): softwood fibers. The patterns of the cracks around the pits expose the structure of the fibrils around the pits.

2. Wood Pulp Nitrocellulose. All of the wood pulp nitrocellulose fibers appear very similar. These are seen in Figures 16 through 18. The fibers appear to show more mechanical damage than the feedstock, wood pulp cellulose fibers. The nitrocellulose fibers have many broken and torn ends and many short fragments. Many of these fibers appear to have been crushed or severely compressed. The fiber surfaces have numerous cracks and smooth-edged pores. These pores range from 0.05 to 0.3 μm in diameter, with an approximate average diameter of 0.1 μm .

The stress crackings visible on the wood nitrocellulose fiber surfaces as seen in Figures 14 through 16 appear to be less regular than those of cotton. The primary cell wall of wood is thicker than that of cotton, and is still intact in these nitrocellulose fibers. Some indication of the underlying secondary cell wall structure can be seen in Figures 17(c), (d), and (e) and in Figure 18(c). Figure 17(e) shows a region where the fibril bundles appear to have been separated into a network of microfibrils. This type of network and the overall surface cracks of the wood pulp fibers indicate that there are very few structural fracture planes in the fibril bundles and that the structure of the wood pulp primary wall is less ordered than that of the cotton fiber S_1 cell wall. This is consistent with the basic structure of plant cell walls previously discussed.

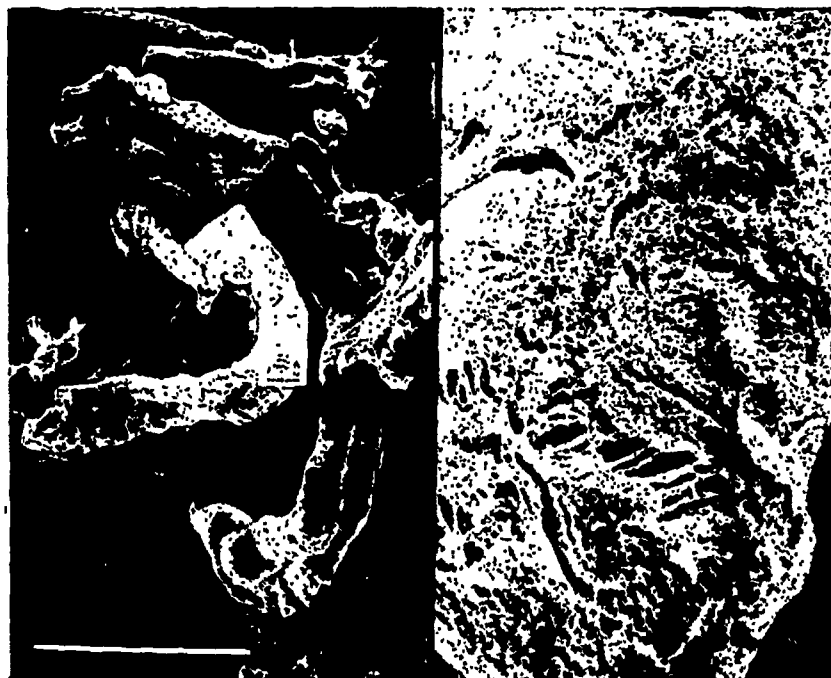
Figure 17. (Cont'd)

Comment: These fibers are a blend of Lots P-1 and P-7. The fibers display significant mechanical damage and crushing. Note the porosity of the fiber surfaces in micrographs C and E. Both micrographs show

Comment (Cont'd): the round, smooth-edged pores along with a large number of cracks in the outer cell wall that expose the fibril structure in the inner cell wall layers.
